# Preventive Maintenance Strategy of Bara Katra

**Mohammad Sazzad Hossain**

## Abstract

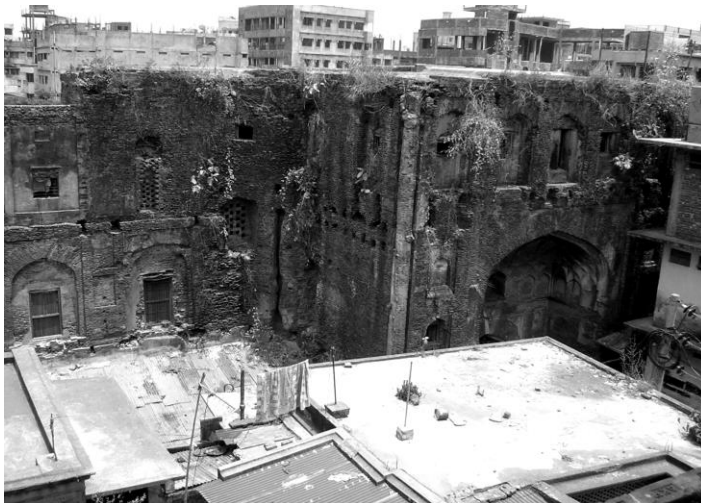
08

**Figure 08:** Open terrace on 1<sup>st</sup> and 2<sup>nd</sup> floor

The finishing layer of floor is removed from most of the floor surface and the new repair works failed to maintain the slope to drain off the rainwater. Rainwater accumulates on the terrace and roof due to the lack of proper slopes to drain the water. As toilets and ambulation spaces are recently located on the terrace of second floor and the sewerage line are drawn to the west side for disposal to the main line that also causes problem.

- Leakage on the roof should be repaired. Proper drainage system in and around the building may be developed. To stop capillary action abstraction of water should be reduced and ground subsidence should be controlled. Damp proofing course may be carried out at plinth level and wall surface.

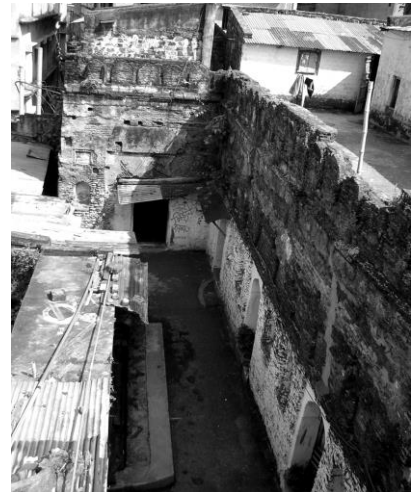
09

**Figure 09:** Existing south wing

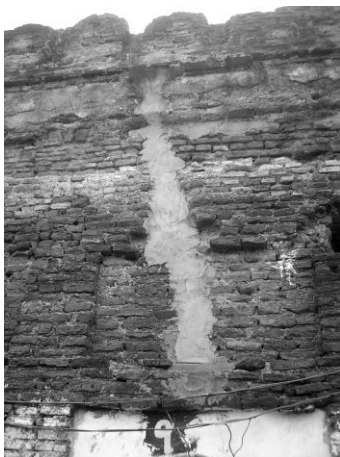
10

Between the entrance and the octagonal turret at the east a prominent crack seems to bisect the entire southern wing. The crack is clear in elevation and both side of the slabs. The crack is now filled with cement mortar. (Hossain, 2006b.)

**Figure 10:** Major Crack (Source: Photograph by the Author)

- Whole property line has to be demarcated and proper documentation should be carried out. All the illegal structures within the property should be removed and the enclosed courtyard should be vacant completely.
- Necessary repair work may be carried out to protect the monument from major structural damage that has divided the southern wing through prominent crack between entrance and octagonal turrets at east.
- Consolidation may be required for repair work at foundation level. Repair work may also be carried out for damages on structural elements like load bearing brick walls that are partly destroyed because of weak brick bonding. Arches, vault roofs that are damaged and have the possibility of collapsing may be repaired.

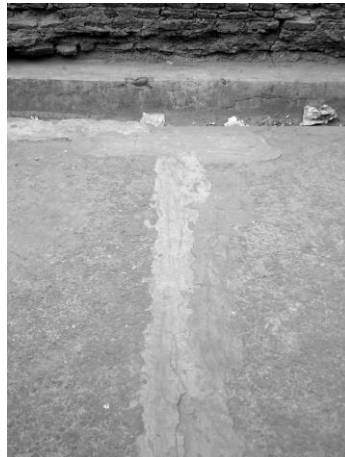
11

**Figure 11:** Continuation of major crack at floor (Source: Photograph by the Author)

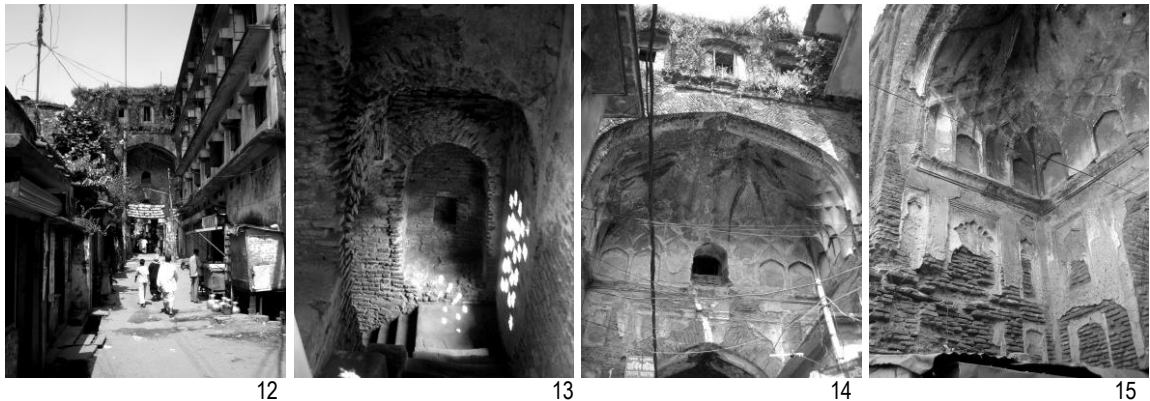
Most of the original plaster has come out and in many cases traces of different layers of original plaster is exposed. Both internal and external wall has deteriorated to extent that the bricks are coming out. Cracks are also found on these load bearing walls especially at the points where arches rest. Presence of vegetation is found on outer walls, resulting in cracks through their spreading roots. Efflorescence is identified from the traces of crystallized forms on the wall surface.

The two major stairs leading to the 2<sup>nd</sup> floor from the ground floor are severely damaged. The eastern one is reconstructed but the western one is standing with damaged surface.

**Figure 13:** Stair case (Source: Photograph by the Author)

**Figure 15:** Plaster removed from wall (Source: Photograph by the Author)

- Restriction on further live load and traffic vibration should be introduced.
- Restoration work should be done on the staircase that is highly damaged. Broken parts of the building especially stair at the terrace of the 2<sup>nd</sup> floor, parapets walls should be restored.

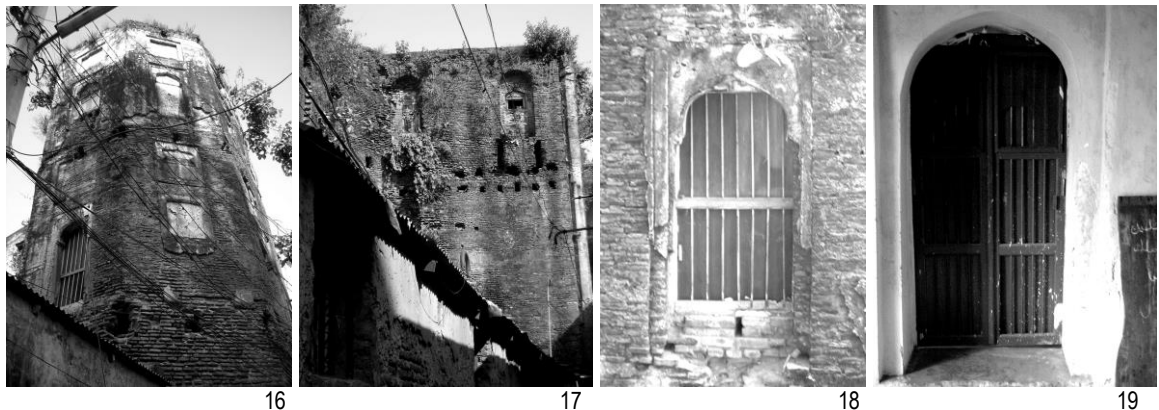
**Figure 16:** Plaster detail (Source: Photograph by the Author)

**Figure 18:** Doors (Source: Photograph by the Author)

**Figure 19:** Windows (Source: Photograph by the Author)

The old door and windows that are considered original are found in poor condition. Color, polish and most of the iron grills have disappeared. Rust in iron and deterioration of wooden surface is a common feature. Alternations are made but there is a similarity between the old and new one.

- Necessary repair work to recover details on plaster at the outer and inner walls should be carefully handled. Proper finishing work in the floor and stairs based on special technical method followed in *Mughal* period should be carried out.
- Restoration of door and windows with proper details should be done and all the recent addition and changes should be substituted by original typology.
- For proper access to urban services like water supply, sanitation, waste management, garbage disposal, drainage, electricity the existing set-up should be scaled up. Electrical wiring, fittings like switch sockets, fans, and lights should be properly checked and totally replaced for safety.
