Exploring morphological changes of the oldest core of Dhaka city for conservation

Wahida Iffat

Department of Architecture, The University of Asia Pacific, Dhanmondi 4/A, Dhaka.

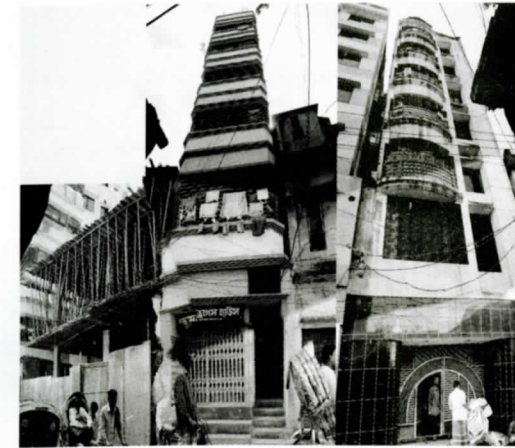
After independence the growth of the city has been phenomenal and brought changes of a greater magnitude than ever. This transformation is in both demographic and physical terms. The recent transformation has put this rich and varied architectural heritage under the threat of disappearance and disfiguration. Already many of Dhaka's historical buildings and areas have either totally disappeared, or are under the process of disappearing. Present demands and activities along with people's negligence, in preserving the old structures are the main reasons for such deterioration. Some of the old structures are being demolished and replaced with new ones. [Fig 04, 05, 06]

Figure 04: Old structures are being replaced with new 6 storey buildings

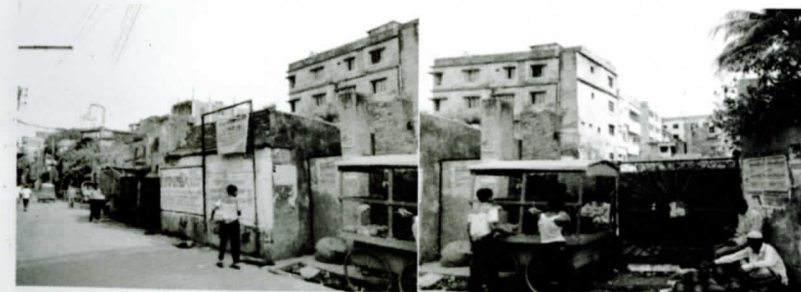
Figure 06: Holding no 33, Paridas lane, currently [2011] in a vacant state, demolished for redevelopment.

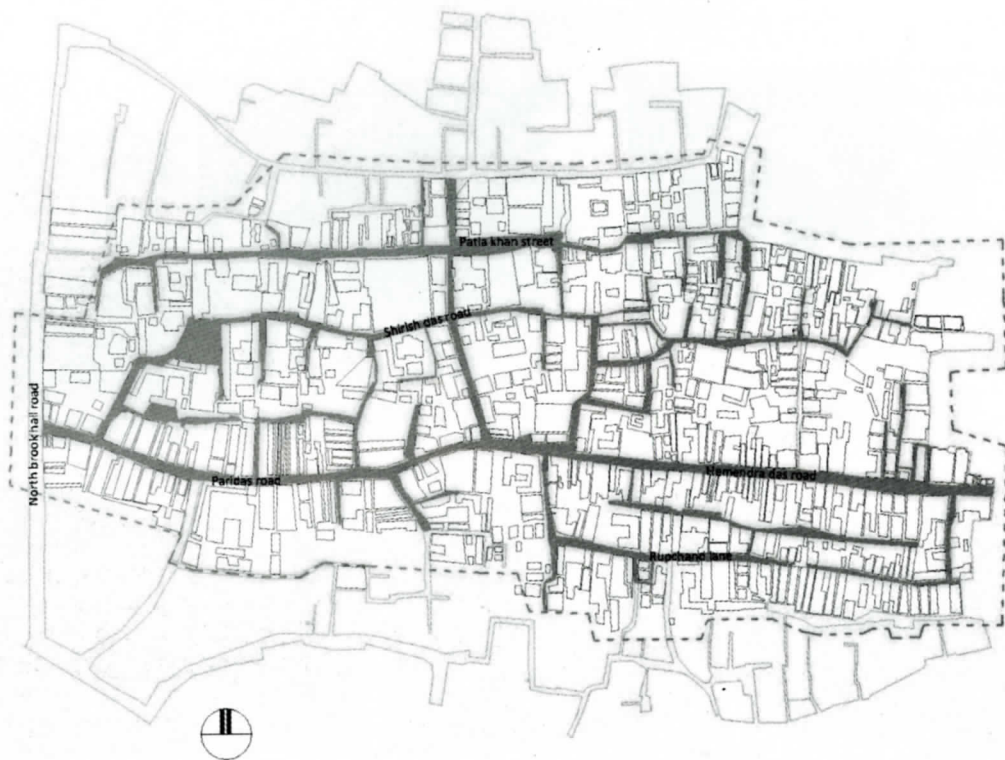
The survey area is bounded by Patla Khan Street in the north, part of Pari Das Lane and part of Rupchand lane in the South, North Brook Hall road in the west, Hrishikesh Das Road in the east. [Fig 07]

Figure 07: Boundary of survey area

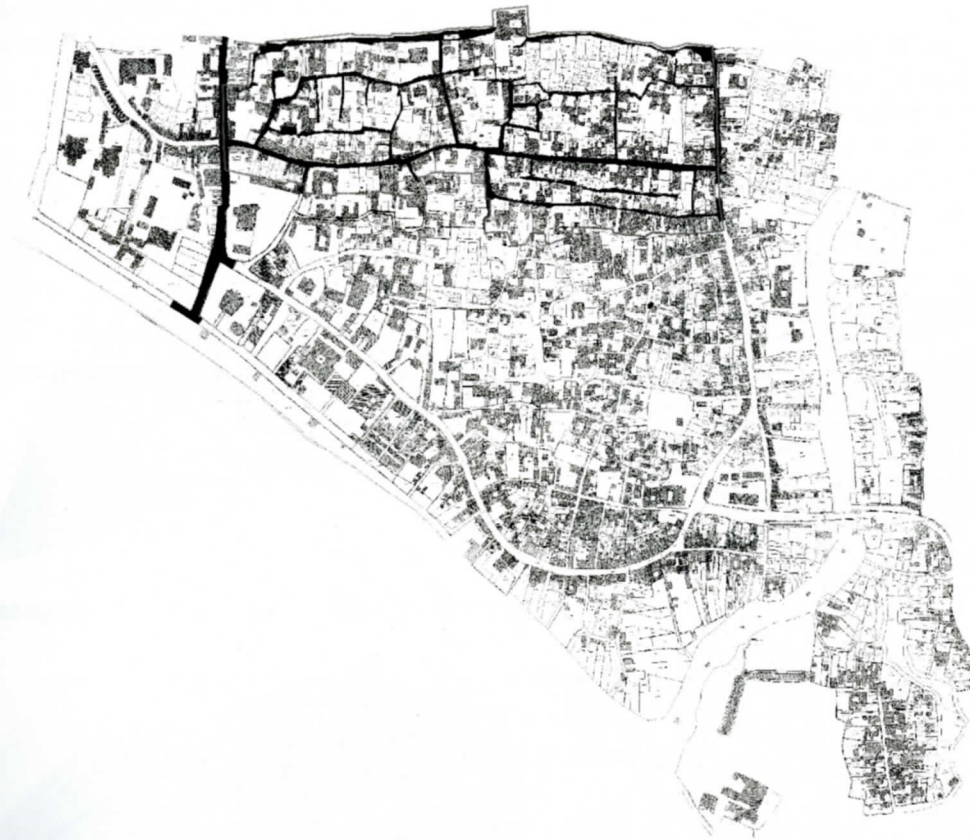
Fig 08: Ward no 79, survey area_ Bangla Bazaar_ street_ Shirish das, Pari Das and Rupchand in CS map

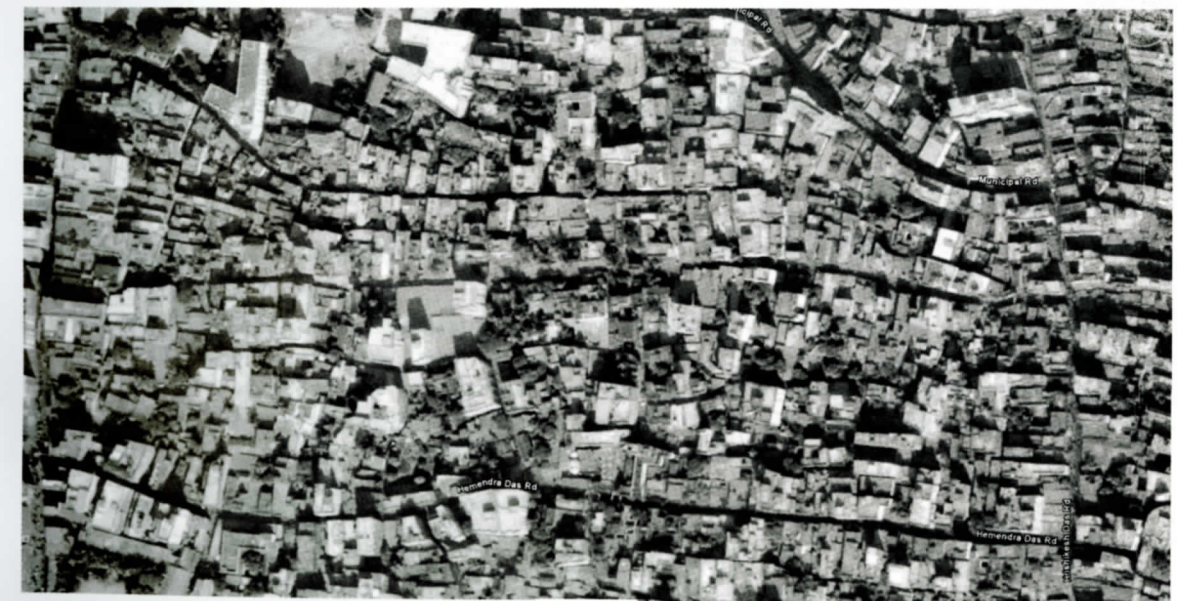
Fig 09: Survey area_ Bangla Bazaar_ street_ Shirish Das, Pari Das/Hemendra Das and Rupchand at present goggle image.

The new developments are more or less six storeys, or in some cases higher, which is destroying the overall scale of the road and the area.

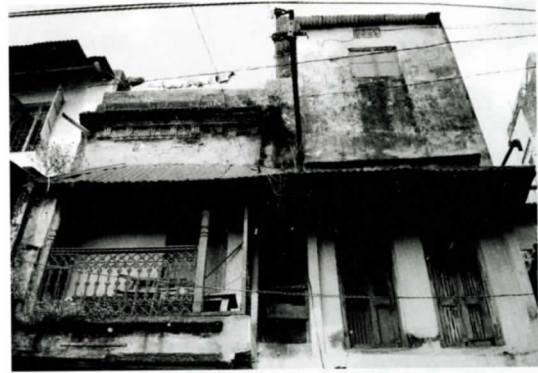
Fig 10: Extension work is common feature

The architectural styles are different from the old existing buildings. Moreover, the owners, being unable to restore or conserve their property, are being forced to demolish, or rebuild, their properties. A large number of buildings have been extended both vertically or horizontally, sometimes even without leaving any trace of it. Again large plots are being divided into multiple plots. Thus the area, which was once a posh area with large buildings having courtyards and open spaces are getting destroyed. [Fig 10, 11, 12]

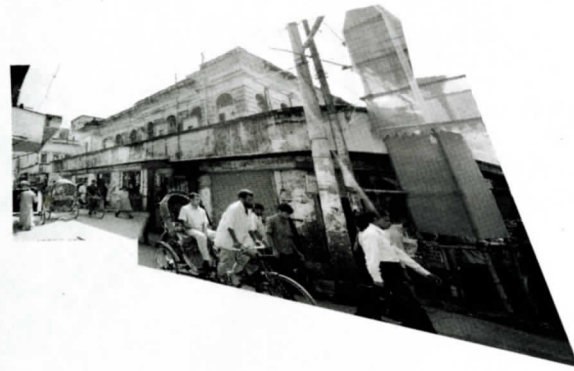
Fig11: Use is replaced - residence-turned into storage space

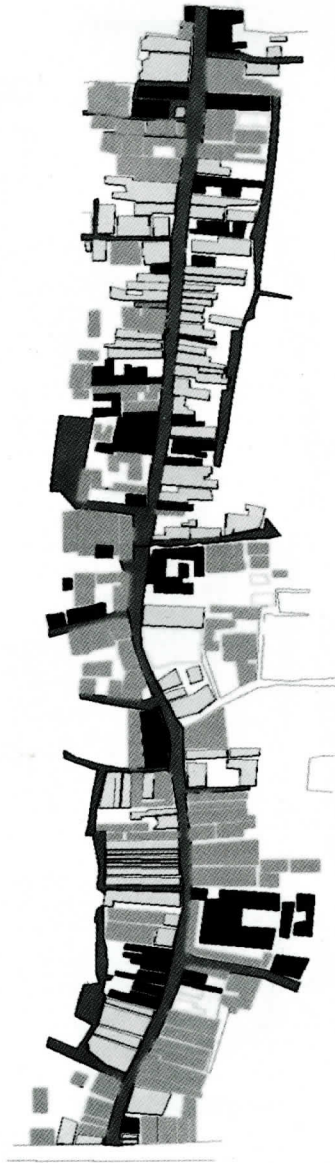
Fig15: Paridas lane in CS map 1912-15

Fig 16: Paridas lane in GIS map 2003

- Structures that changed morphologically
- Addition, extension, divided.
- Structures that remained more or less unchanged
- Vacant plots

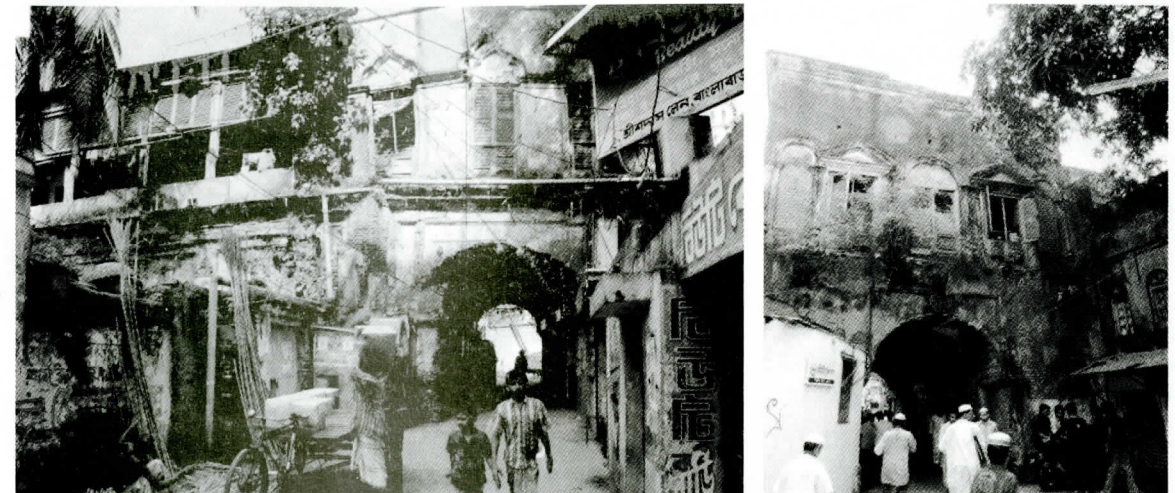
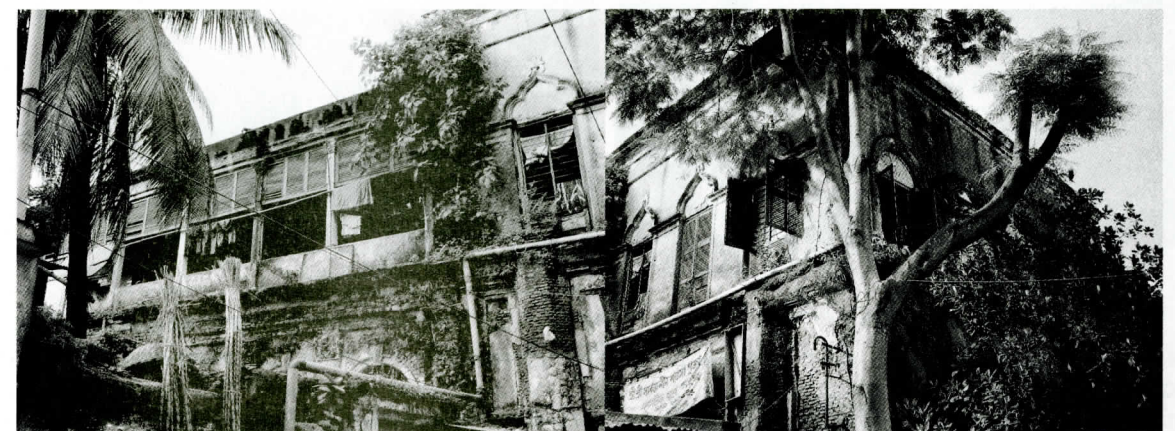
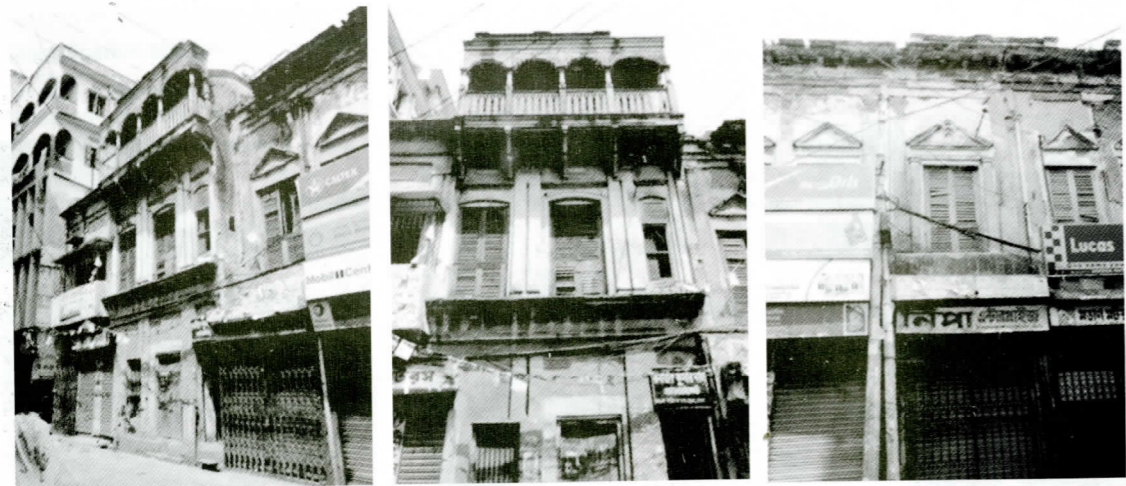
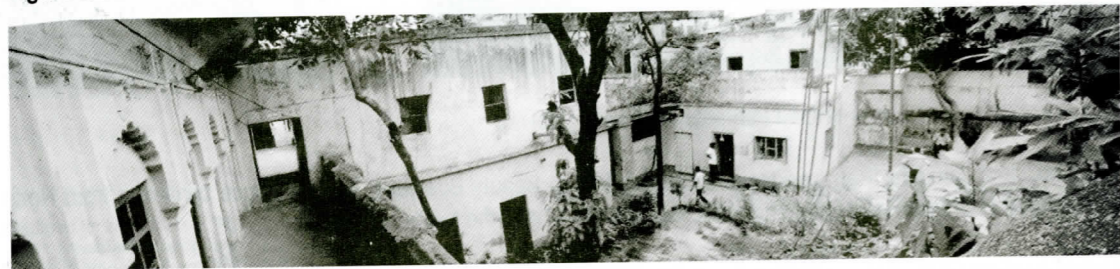
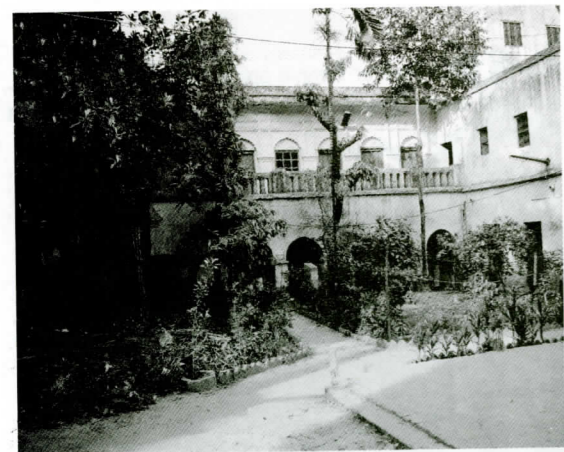
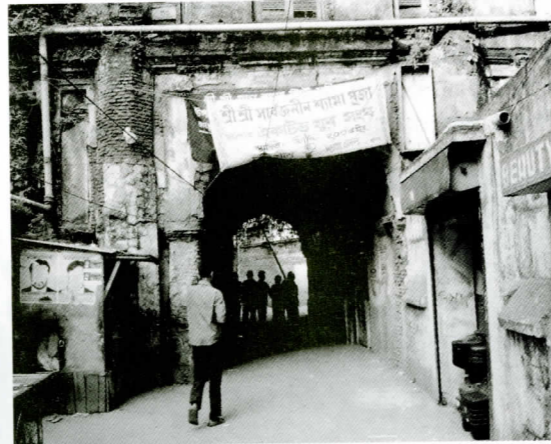
Fig 20: 1, 2_Shirish Das Lane_ arched approach acts as a gateway.

Holding no: 1, 2 Jamindar Bari [residence of Shirish Babu], Beauty Boarding. The residence continues from North Brook Hall road to Shirish Babu Lane and stretches over the lane in the form of a gate way.

Use: Originally a residential building, part of which was later converted to Shonar Bangla press and existed till 1948. After that from 1950s the press was converted to a Boarding named Beauty Boarding. At present the main part of the building is used as Farida Bag police station and residence at the same time.

Architectural style: The building's arched entry/ gate way towards the Shirish Das lane gives the building a kind of land mark effect. It is assumed that it was built in the late 17th century or in the early 18th century containing certain elements of colonial style, such as the use of Corinthian/ ionic columns, wooden sun breakers, steel beams (kari barga), cast iron railing and arches. Different types of arches have been used in the different facades. The construction material suggests that the time period of construction may be in Mughal period, and it appears to be an amalgamation of different architectural styles of different period.

Consideration for conservation: Beauty boarding has historic, cultural as well as some political importance. The place had been used by film makers, journalists, writers, movie makers as place of congregation. The front court yard is still used as space for people to gather, as well as an entry to the boarding house. Though both holdings no. 1 and 2 have been identified as risky buildings in the City Corporation data base, 2004, they should be conserved as landmarks, due to the social and cultural influences in the area, as well as their distinct architectural features.

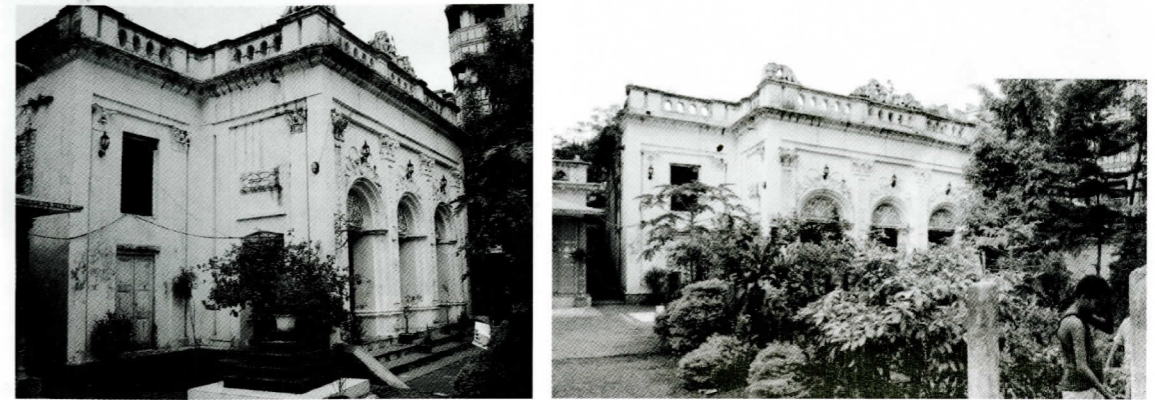
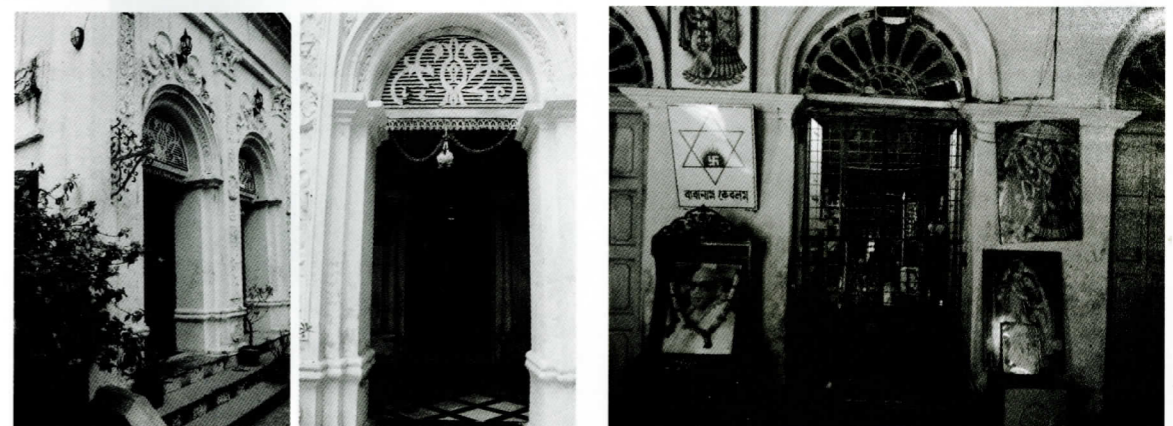
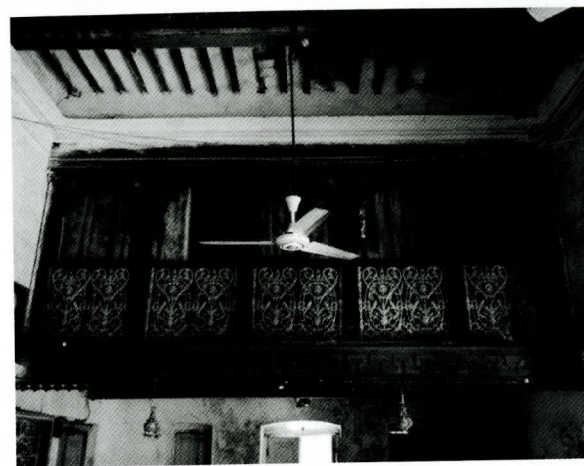
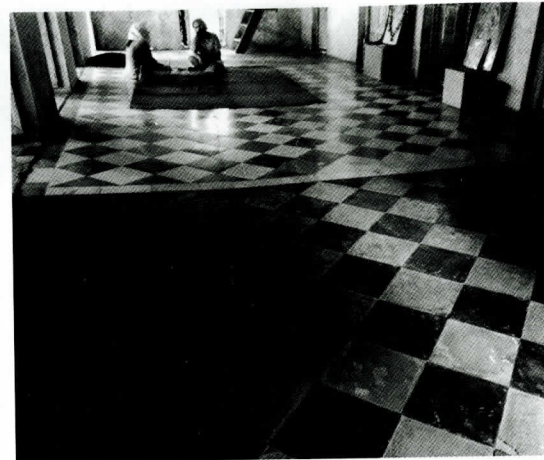
Fig 26, 27: 33_Shirish Das lane_ Sri Sri Pran Bhallov Gue Mandir [Anando Marg Temple]

Fig 28, 29: Cast iron grills and use of stained glass in the doors

Architectural style: The Arched entry and Corinthian columns suggest that the time period of construction may be in the Colonial period. There are two balconies on both sides which are very intricately designed with wooden lattice work. The cast iron grills and stained glass in the doors and diagonally tiled marble floor represents its excellent architectural features.

Fig 30: Wooden lattice work in the balcony

Fig 31: Diagonally tiled marble flooring.

Consideration for conservation: As a religious building the structure serves both social and cultural needs of the area. Moreover, due to its excellent architectural features and style, the temple should be preserved.

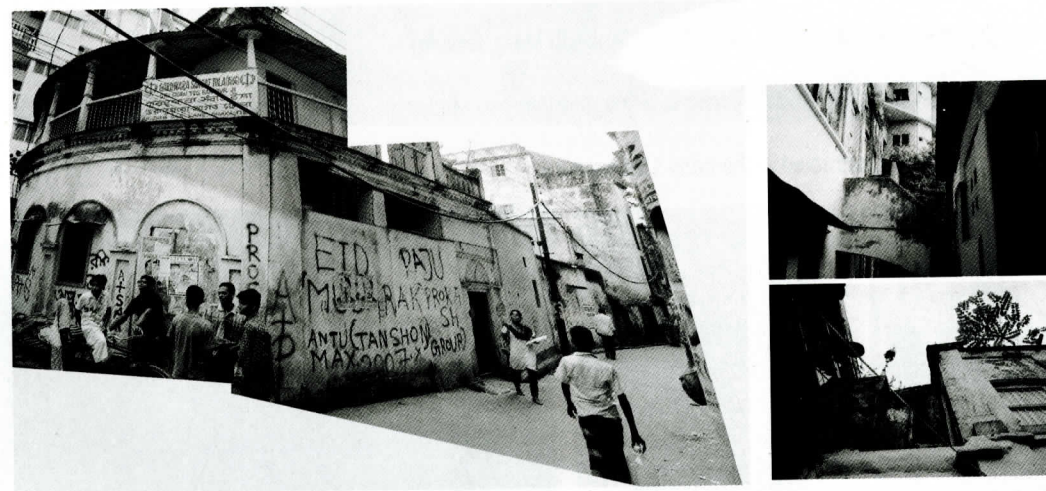
Fig 32: 14_ Shirish Das lane_ Shikh temple- Tegh Bahadur Sangatolla.

Historical background: Tradition says that the ninth Shikh guru, Tegh Bahadur (1) visited Dhaka during the reign of Aurangzeb and built a Sangat hall in moholla Sangattola in Bangla-bazaar of Dhaka. The original building does not exist now, but on the old site a comparatively new building exists, though it has been listed under risky buildings, by the City Corporation data base, 2004. [Taifoor, 1984]

Architectural style: The arched entry, steel columns, suggests that the time period of construction may be in the Colonial period.

Consideration for conservation: As a religious building and for distinct architectural features it should be preserved.

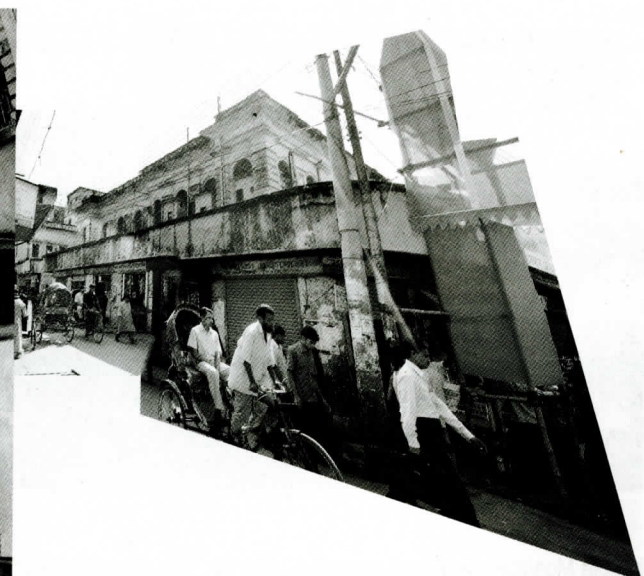
Fig 34: Arched entrance at 1_ Harish Chandra Bashu road

Fig 35: View from Pari Das road side

Architectural style: The building is constructed in the Colonial style and is grand in scale and well-maintained.

Consideration for conservation: Due to its architectural features it should be preserved.

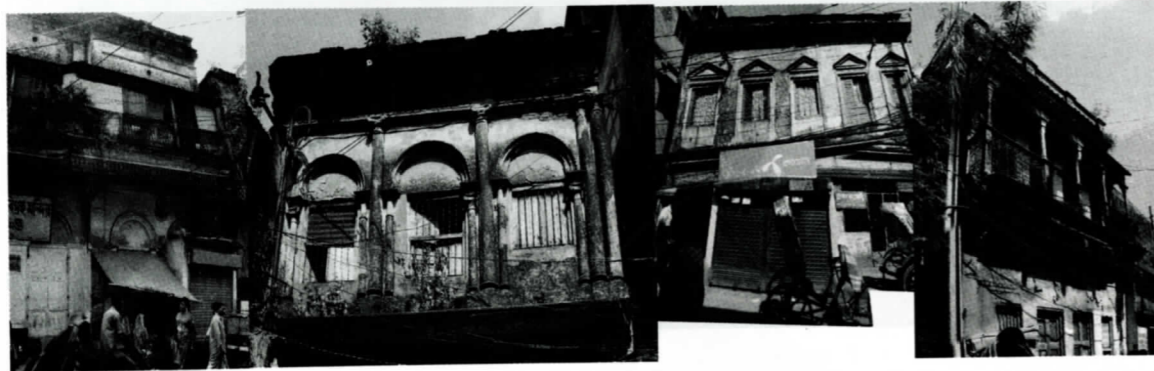
Holdings no: 32, 61, 54, 63 Pari Das road.

Architectural style/ features: Colonial with temple architectural style. Chun Shurki (lime concrete) and Jafri brick (brick designed for screens) is used in construction work. Steel column, cast iron railing suggests Colonial style.

Consideration for conservation: Religious structures as well as buildings in rows, forming an integrated pattern of linear development and historic properties behold the ambience of the whole area, which should also be considered for conservation.

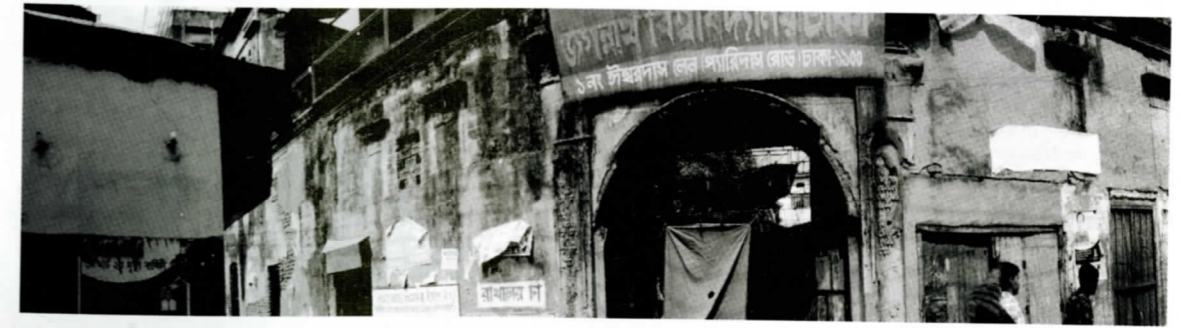
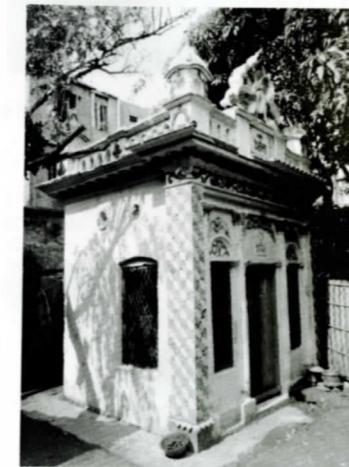
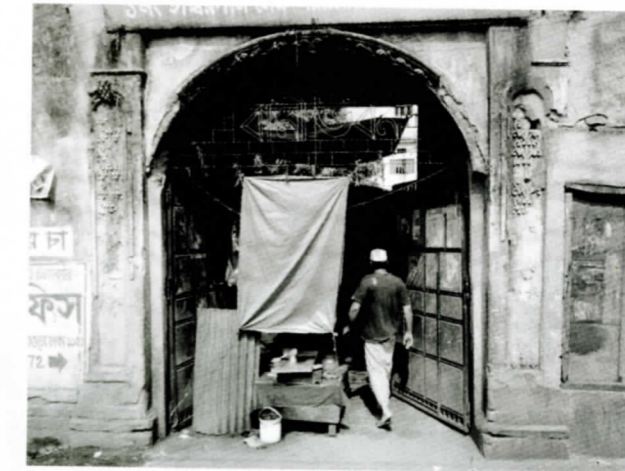
Fig 39: 1_Ishwar Chandra Das Lane, Paridas road- Students' Hostel

Architectural style: Certain features of the building followed the Colonial style, like the arches, cast iron railings, etc. There is a small temple in the inner court.

Fig 40: Temple in the inner court

Fig 41: Entrance to hostel

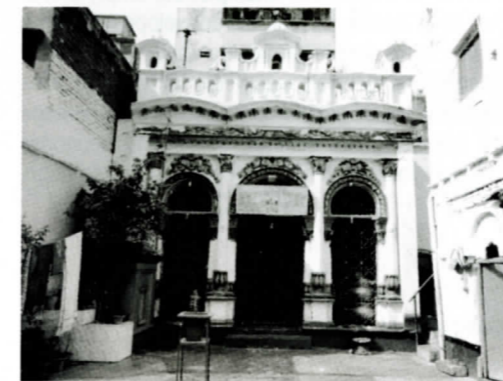
Fig 48:8/2_ Sree Sree Krishna Chandra jee Bigraha temple Fig 49: 16_ Hazrat Baba Shah (R :) mazzar.

Rupchand lane is one of those few streets which haven't changed much morphologically, so it is possible to bring this road under area conservation because this road is very important in the matter of heritage integrity and preserving ambience of the whole area.
